Spectrem Lock Strip Restoration Overlay

TREMCO
Commercial Sealants & Waterproofing

Lock Strip or Zipper Wall Gasket Systems

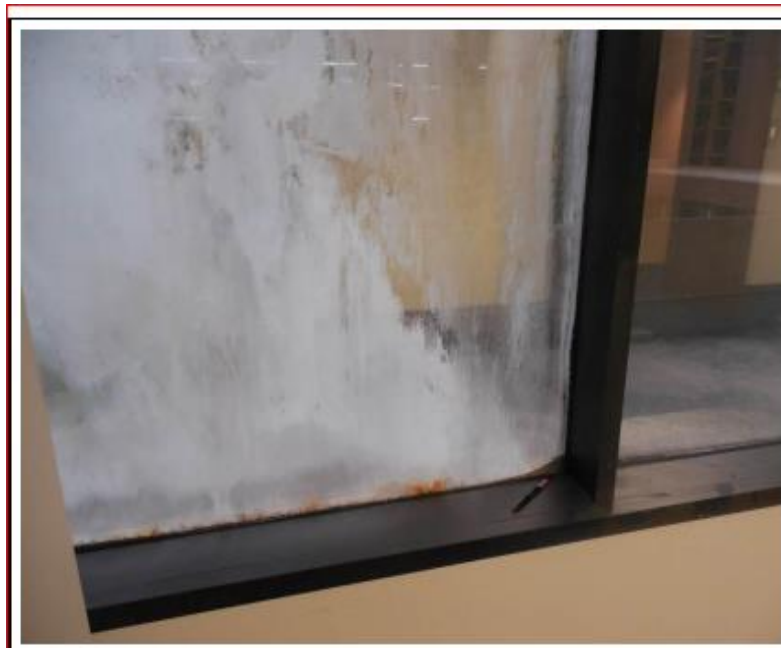
PHOTO #3.
Failed IGU.
Note the moisture stains at the interior of the airspace as well as the loose desiccant material outside the spacer at the lower right corner.

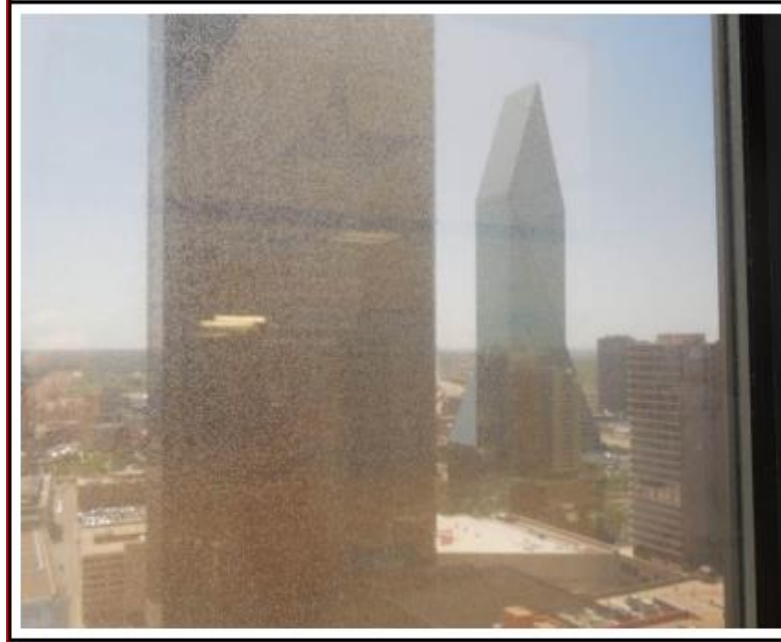
PHOTO #4.
Failed IGU.
Note the moisture stains at the interior of the airspace.

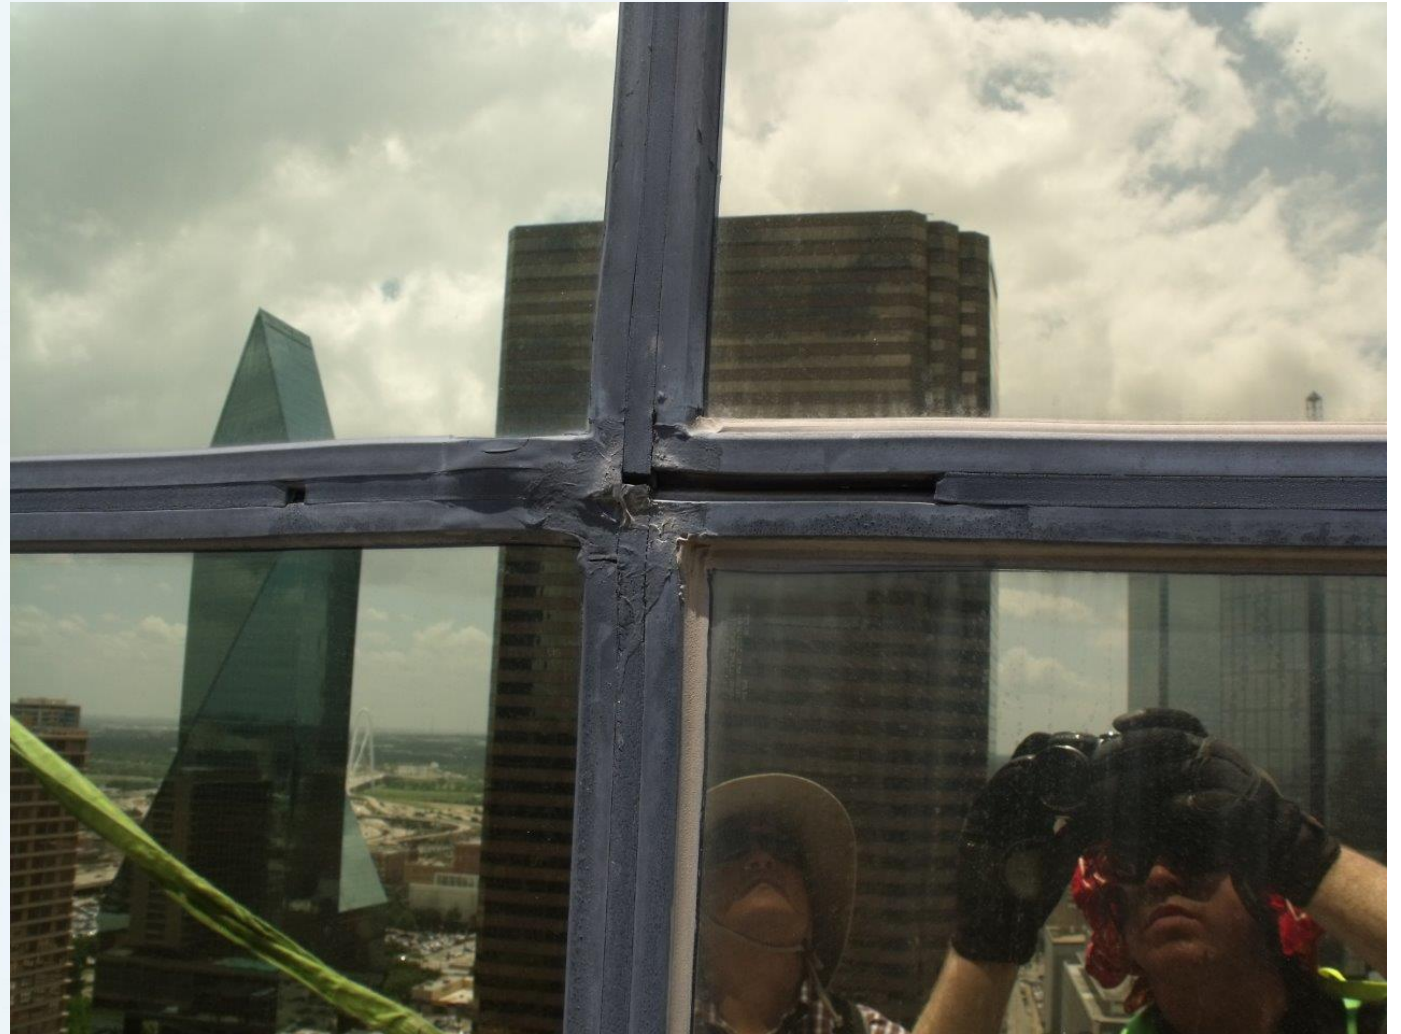
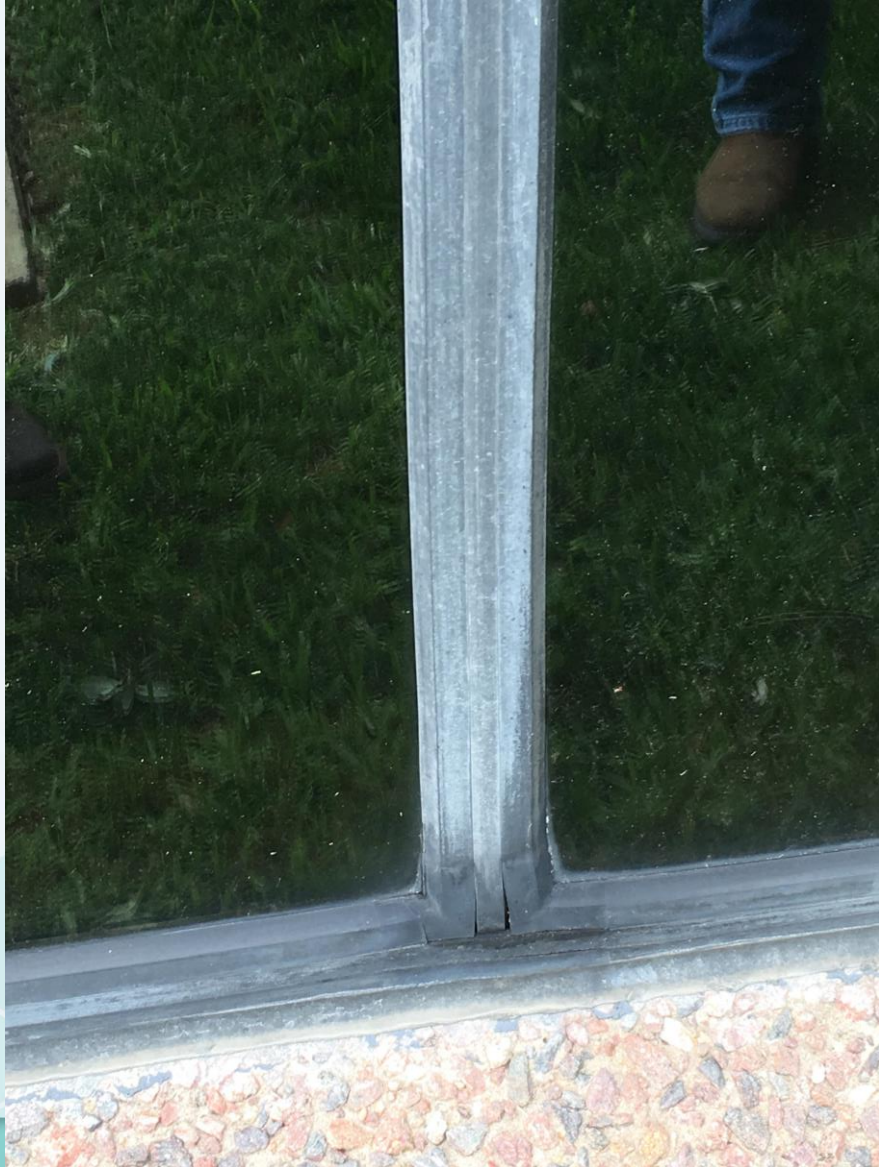
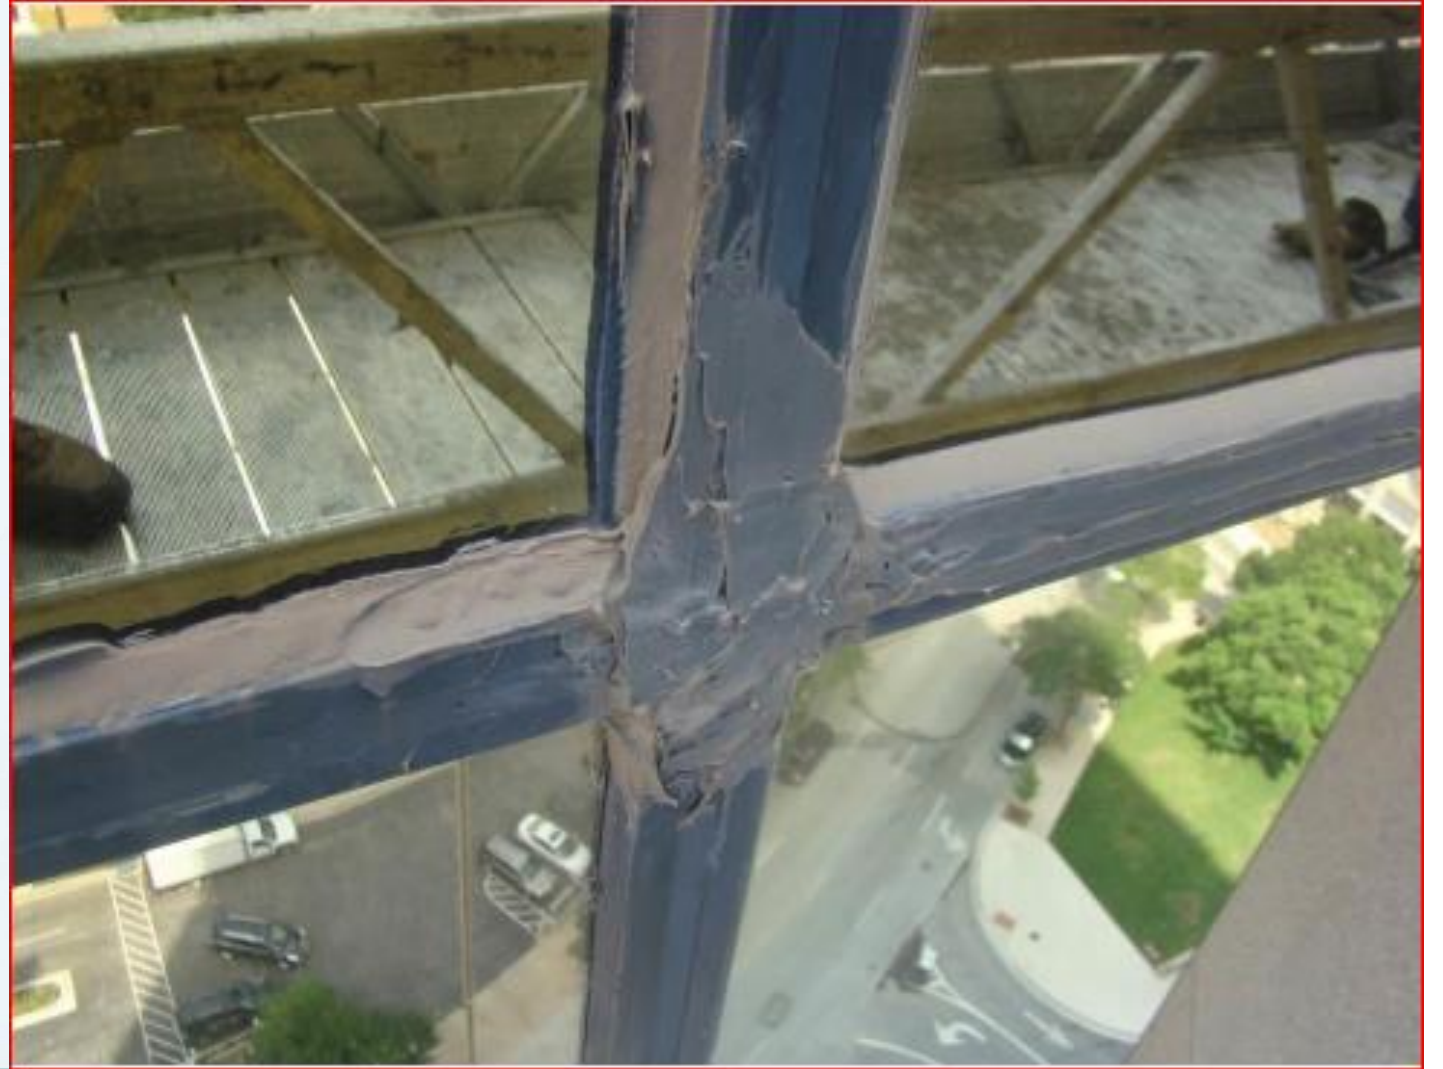
Examples of Aging Lock Strip Glazing Systems

The original black neoprene rubber has become brittle and discolored (gray) from exposure to UV over the years. Water may enter the system, resulting in building leaks and detrimental effects to the insulated glass unit. This continued exposure also causes the rubber to become dry and brittle, resulting in powder residue rundown discoloring windows.

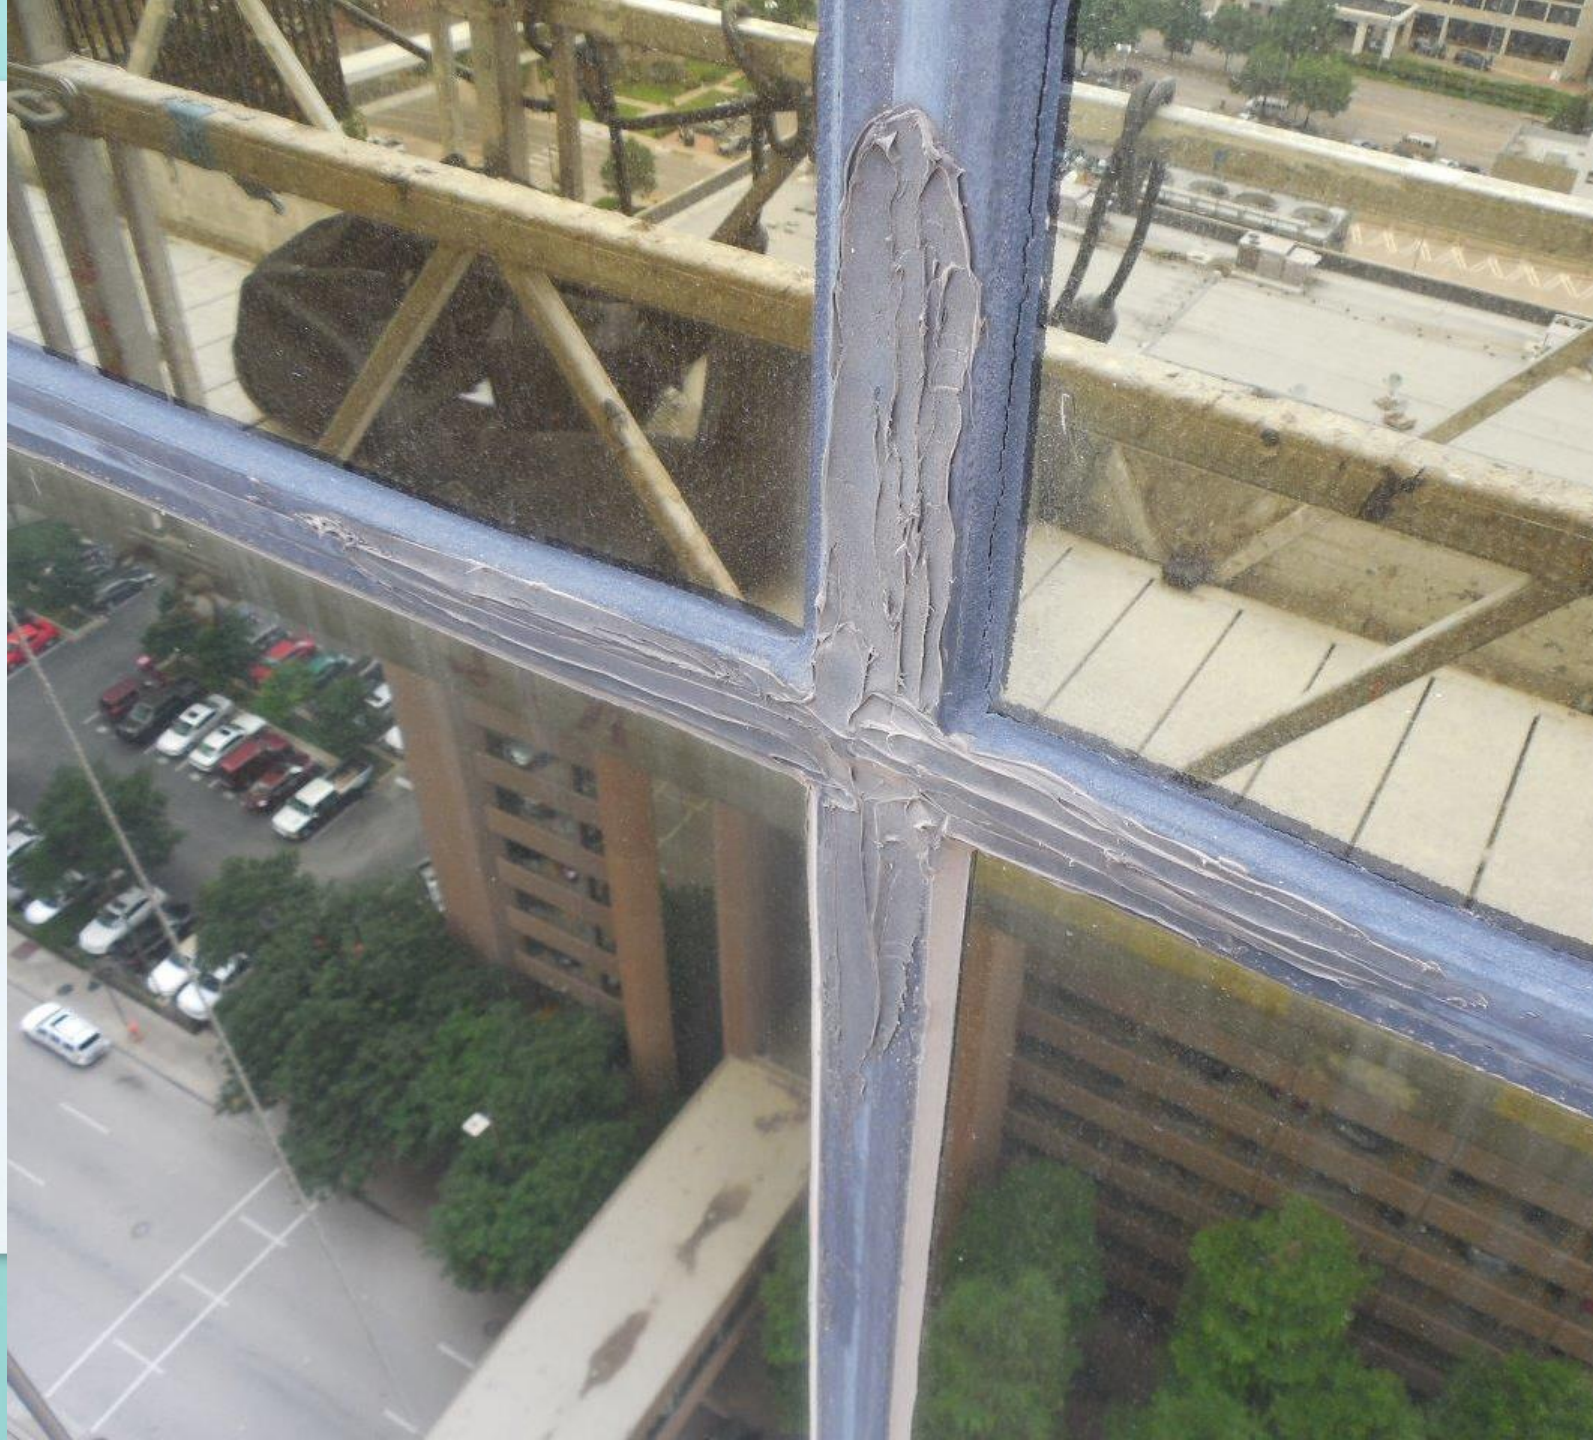
Option #1 - Sealant Spot Repair

- Wet Seal or Sealant Repair
 - Short term fix
 - Normally spot “band aid” repairs
 - Adhesion not guaranteed long term
 - Short term warranty

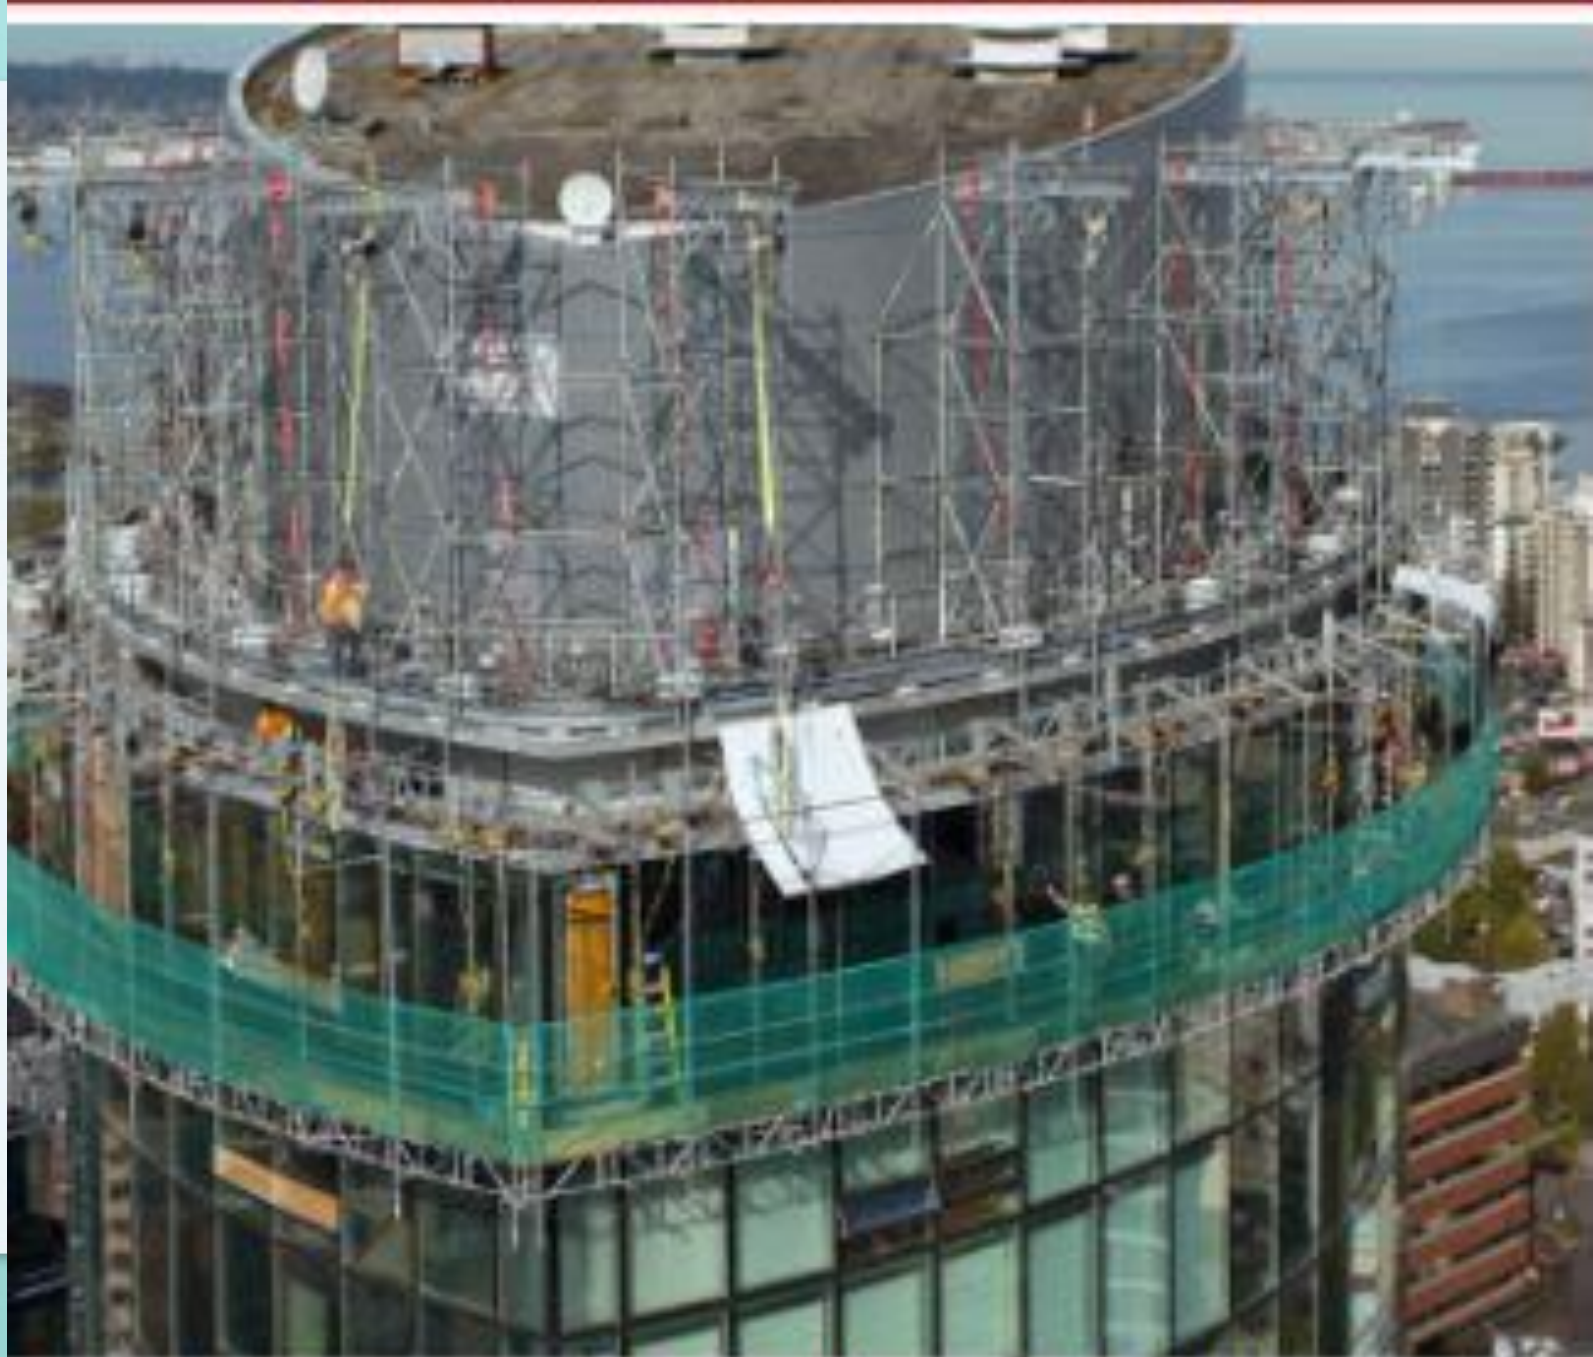
Figure 11: Installed suspended scaffolding and hoist towers

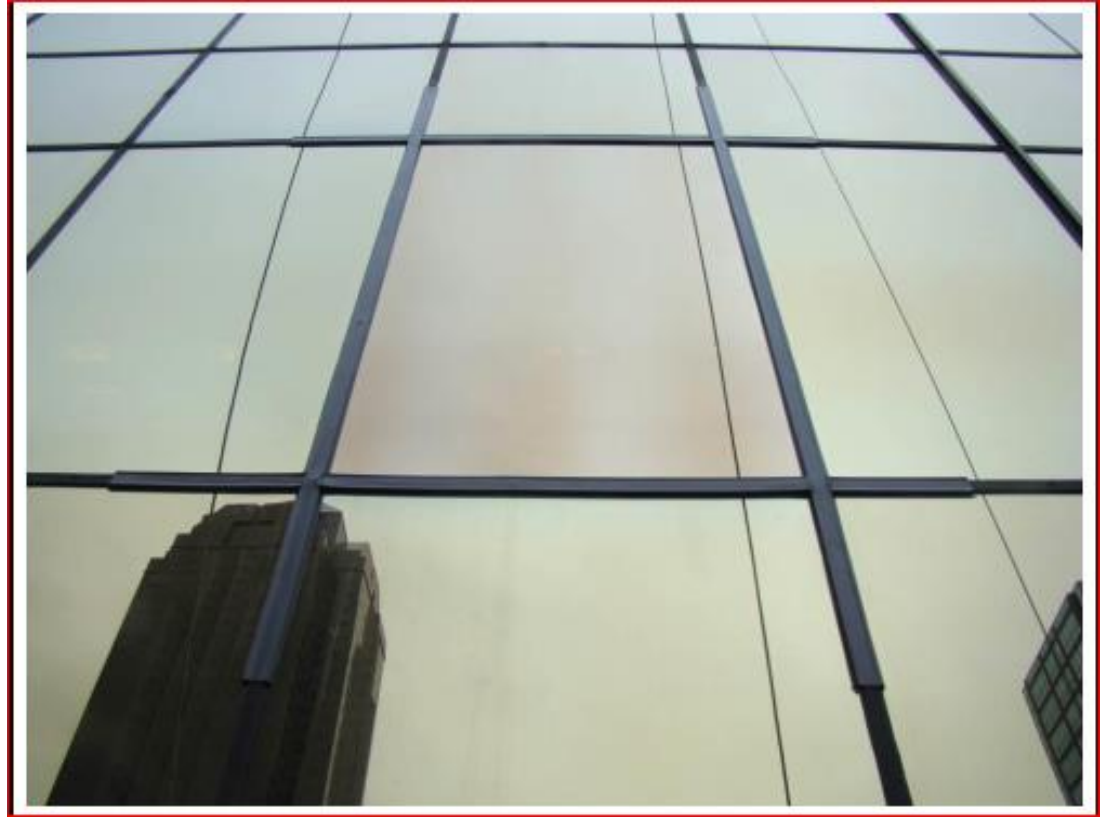
Adhesion Mock Up Test

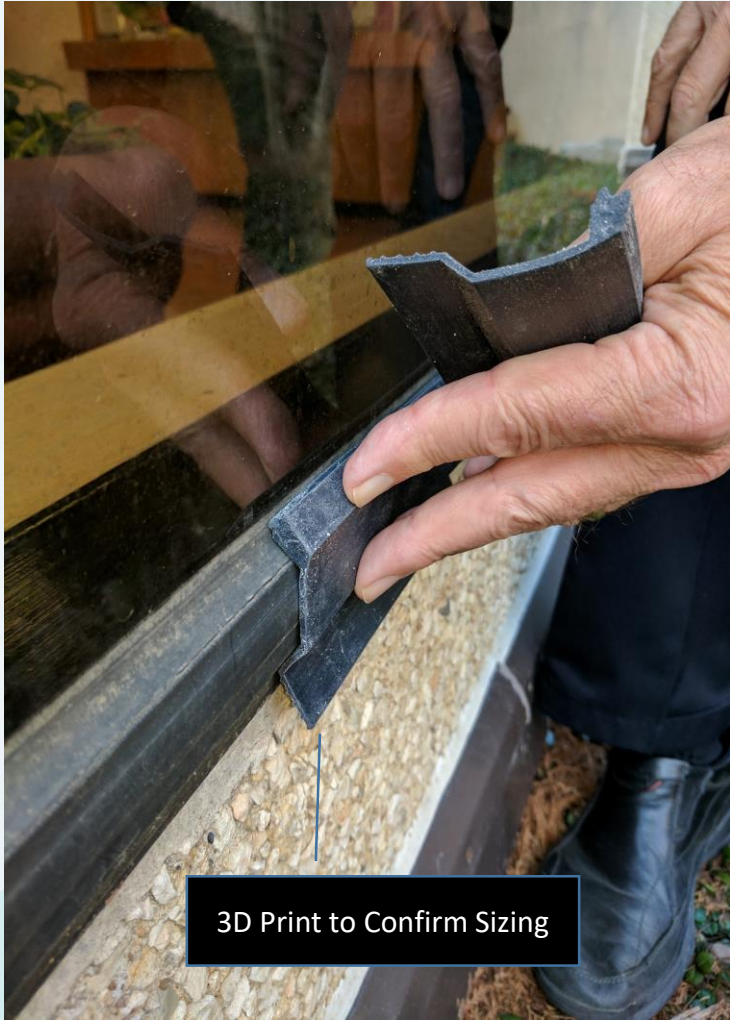
3D Print to Confirm Sizing

- Contact Tremco Rep – Confirm Sizing
- Tremco Design Engineering Group (DEG) Analysis
- Receive DEG Part Recommendations
- Confirm Part (if existing) or DEG Creates Die Drawing for Customer Review
- Use 3D Print to Confirm Sizing
- Get Quotes Through Selected Contractor Network

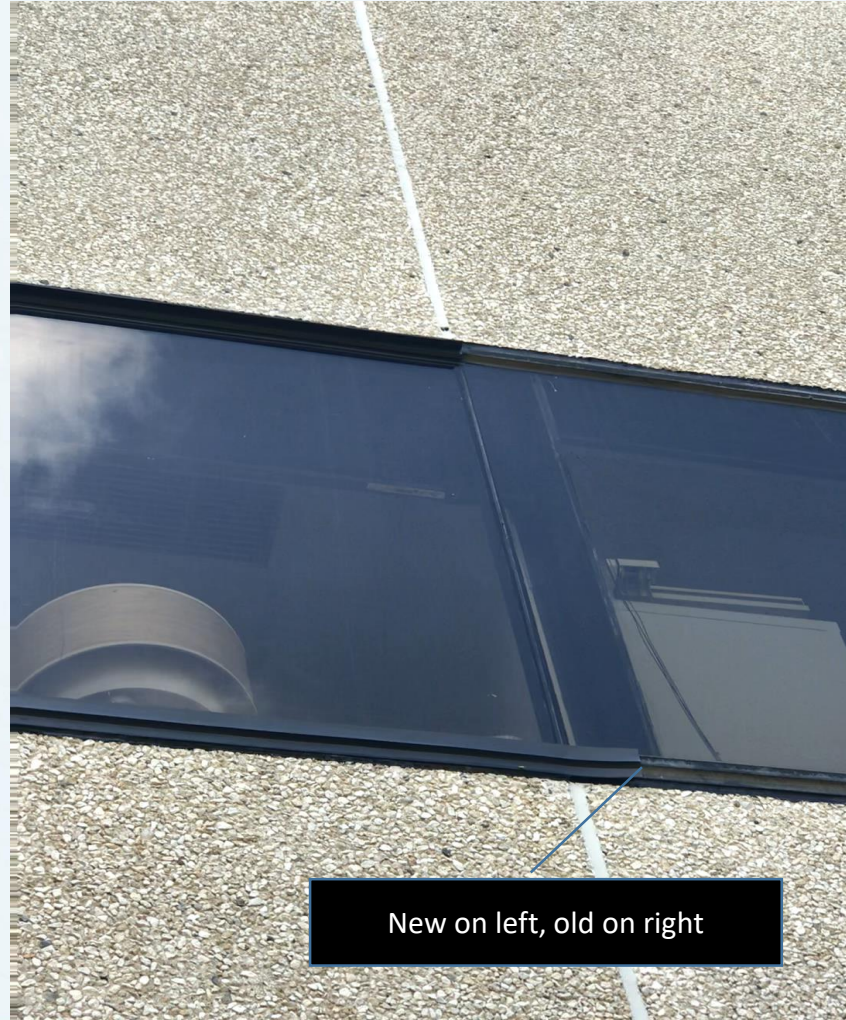
New on left, old on right

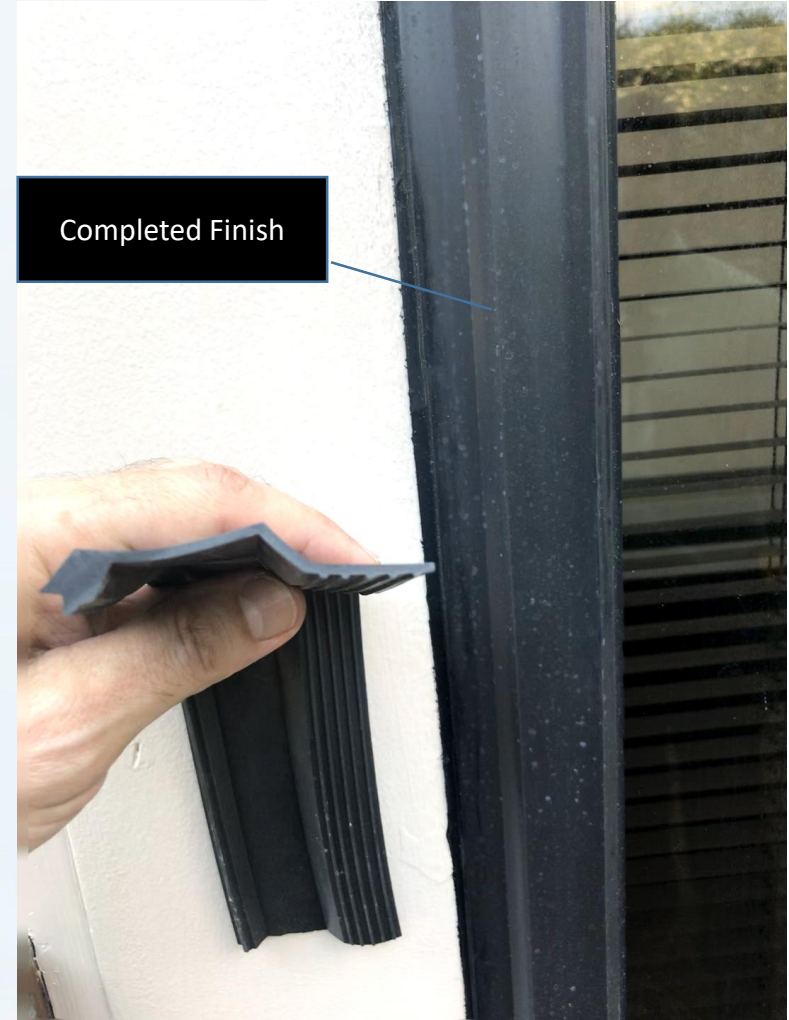
Completed Finish
